## **"Full" Capital Funding Plan**

### **Oxnard Community Facilities Westport Oxnard, CA**

**Report #: 39735-0**  
**For Period Beginning: July 1, 2020**  
**Expires: June 30, 2021**

**Date Prepared: September 28, 2020**

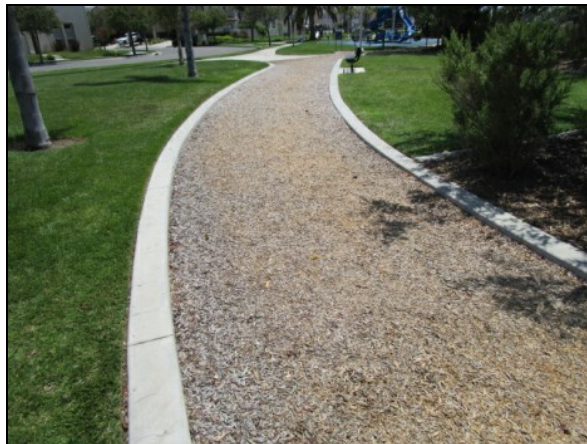
Comments: The nature trails appear to be aging normally. Plan to replenish at regular intervals to maintain good conditions throughout.

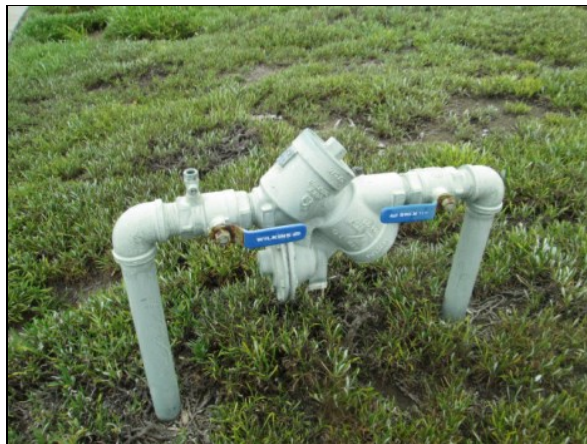
Comments: The backflows were not tested during the inspection. Best to have the device inspected and maintained on a regular basis by a certified plumbing vendor. These devices prevent harmful chemicals from backwashing into your drinking water supply.
